# Prediction and risk evaluation of chalk cliff collapse: the *PROTECT* project

Stig A. Schack Pedersen and Ingelise Møller

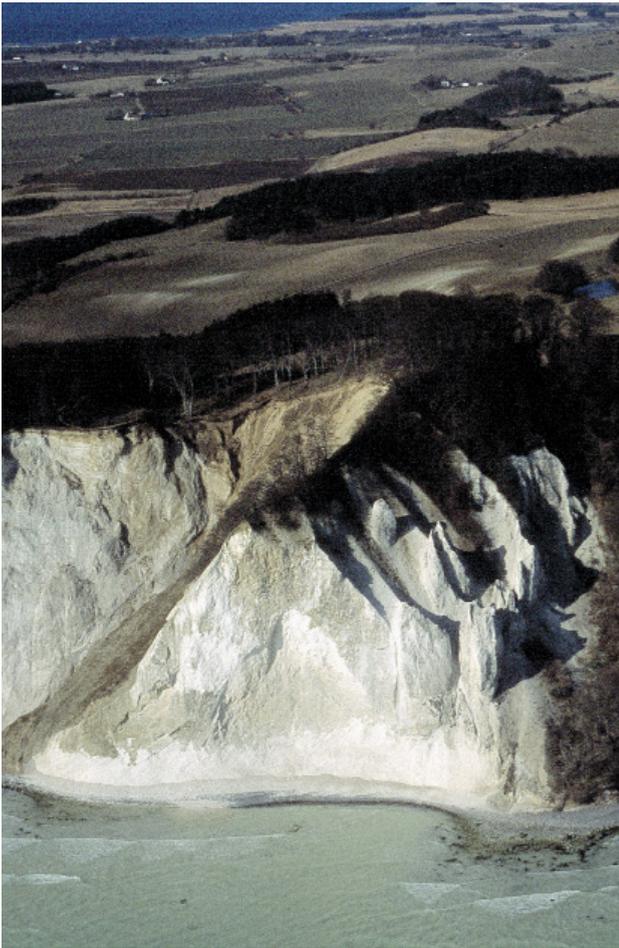
Fig. 2. Oblique aerial photograph of the c. 90 m high chalk cliff at Store Stejlebjerg prior to the rock fall. The photograph was taken on 13 March 2003 as part of a systematic photogrammetric survey aiming at an aerotriangulation of the Møns Klint cross-section for future examinations of structural geology and landslide activity.

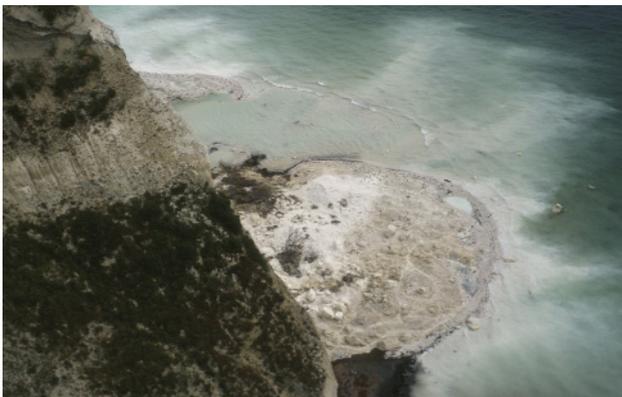
Fig. 3. The broad 90 m long peninsula formed by the rock fall seen from the top of Store Stejlebjerg on 29 August 2003. The preservation potential of these breccias is not high and the peninsula will probably be lost to erosion in about three years.

Møns Klint is a 4 km long N–S-trending coastal chalk cliff up to 130 m high bordering the east side of the island of Møn (Fig. 1). This cliff provides an instructive structural cross-section through a large glaciotectonic complex, the southern part of which can be characterised as an imbricate fan with thrust sheets consisting of *c.* 60 m upper Maastrichtian chalk overlain by 10–15 m glacial deposits of Weichselian age (Surlyk & Håkansson 1999; Pedersen 2000). Store Stejlebjerg forms a nearly 90 m high vertical cliff section that prior to the rock fall had an irregular overhang from about 25 m up to about 70 m a.s.l. (Fig. 2). This overhang formed the basal boundary of the collapse unit, which is estimated to have a volume of 8000 m<sup>3</sup>. The large debris fans formed by the rock fall, constituted a southern 70 m long seawards projecting peninsula consisting of large blocks and a northern 90 m peninsula comprising finer-grained breccia (Fig. 3).

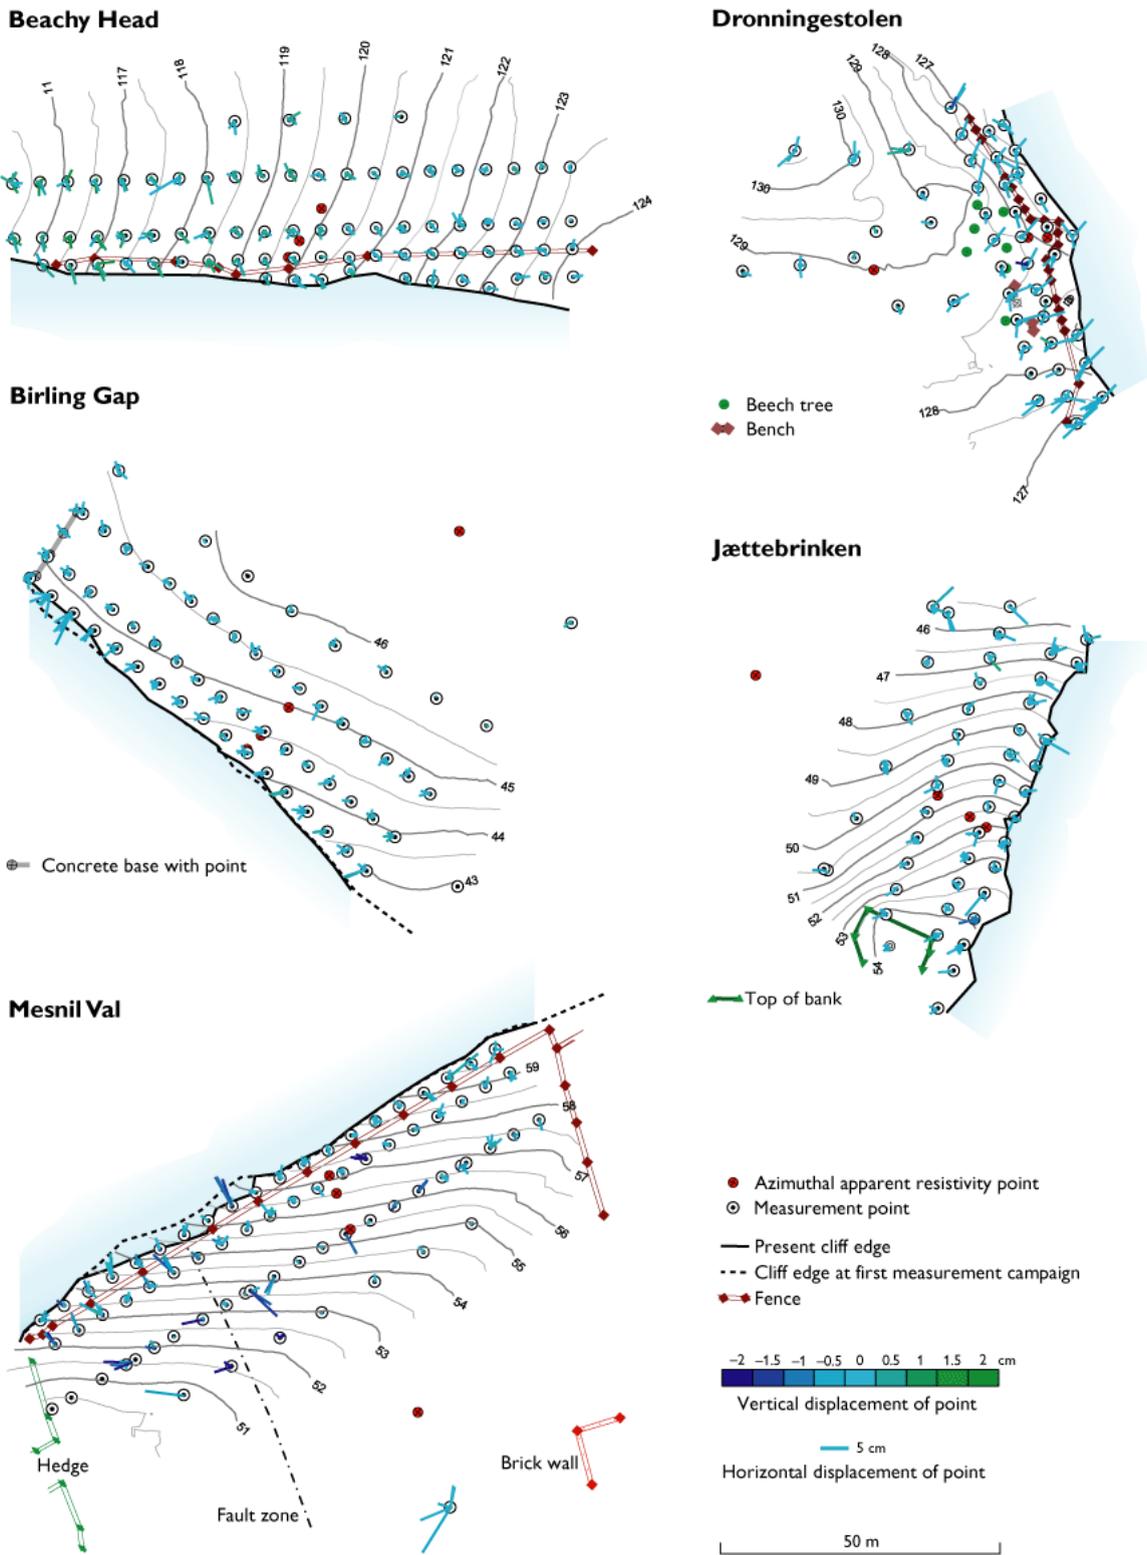
Fig. 4. Maps of the five test sites established for the *PROTECT* investigations. All locality maps drawn with north at top. Contour lines are in metres. Each grid point is provided with a vector bar representing the displacement of the grid point based on repeated measurements. The displacement is relative to the first measurement. Horizontal displacements shown by length of bar (upscaled by a factor of 100). Vertical displacements are shown by colour.

Temporal azimuthal apparent resistivity measurements are made at the five research sites at bimonthly intervals (Figs 1, 4). The parameters required to monitor variations in the rock mass are determined and fracture orientations are calculated for each research site.

For testing the dislocations in the terrain a grid has been established at each research field (e.g. Fig. 4). The grid consists of a number of fixed points that have been measured with a theodolite. In general the deviation of the measurements is within  $\pm 1$  cm on the  $z$ -coordinate. The  $x$  and  $y$  coordinates have a somewhat larger deviation, which is mostly below  $\pm 3$  cm (Pedersen *et al.* 2002). One of the results from the test grid measurements is that the volume involved in the collapse at Mesnil Val in June 2002 could be calculated to 2750 m<sup>3</sup>. Moreover, it is evident that initial creep along the fault zone displacing the Birling Gap field has been documented by the test grid measurements (Fig. 4).
