Preliminary landslide mapping in Denmark indicates an underestimated geohazard

Kristian Svennevig^{*1}, Gregor Luetzenburg², Marie K. Keiding¹, Stig Asbjørn Schack Pedersen¹

¹Geological Survey of Denmark and Greenland (GEUS), Copenhagen, Denmark. ²Department of Geosciences and Natural Resource Management, University of Copenhagen, Copenhagen, Denmark

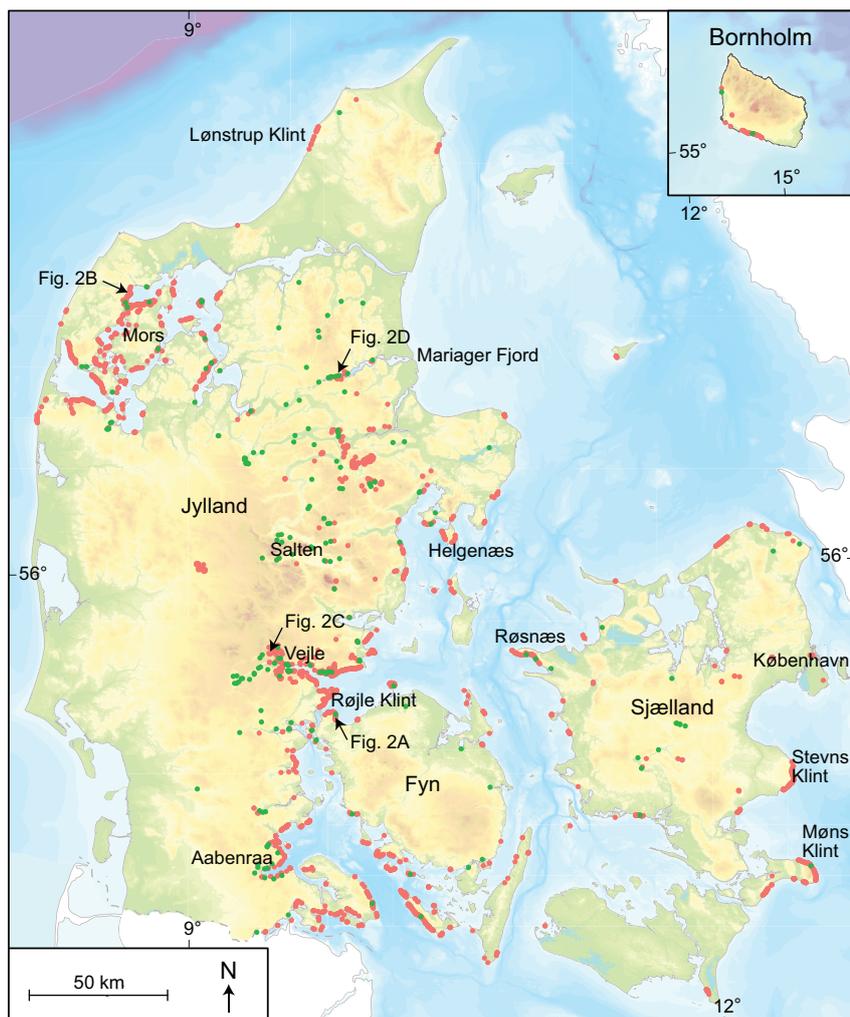
Fig. 1 Mapped landslides in Denmark. Green dots show 172 landforms with overprint of younger processes, such as fluvial incision. Red dots show 2854 landslides that are not modified by other geological processes – some of these show indications of recent activity. Place names mentioned in the text and Table 1 along with positions of panels in Fig. 2 are shown.

At the time of publication, the preliminary landslide inventory consists of 3026 distinct landslides in Denmark (Fig. 1). Of these, 2318 are at or near the coast (<300 m) and 708 are more than 300 m from the coast and considered inland.

A total of 172 landforms, some exceptionally large, fit the morphological criteria for a landslide but have a morphological overprint by younger processes such as fluvial incision (see Fig. 1). These may be interpreted as landslides formed during periglacial or paraglacial phases of landscape development (Fig. 2D). These extraordinary landforms resemble large-scale landforms in Aabenraa, southern Denmark, identified as possible landslides by Lykke-Andersen & Sørensen (2018) and could have played a hitherto unrecognised role in degrading the Danish landscape in postglacial times, which calls for further investigation.

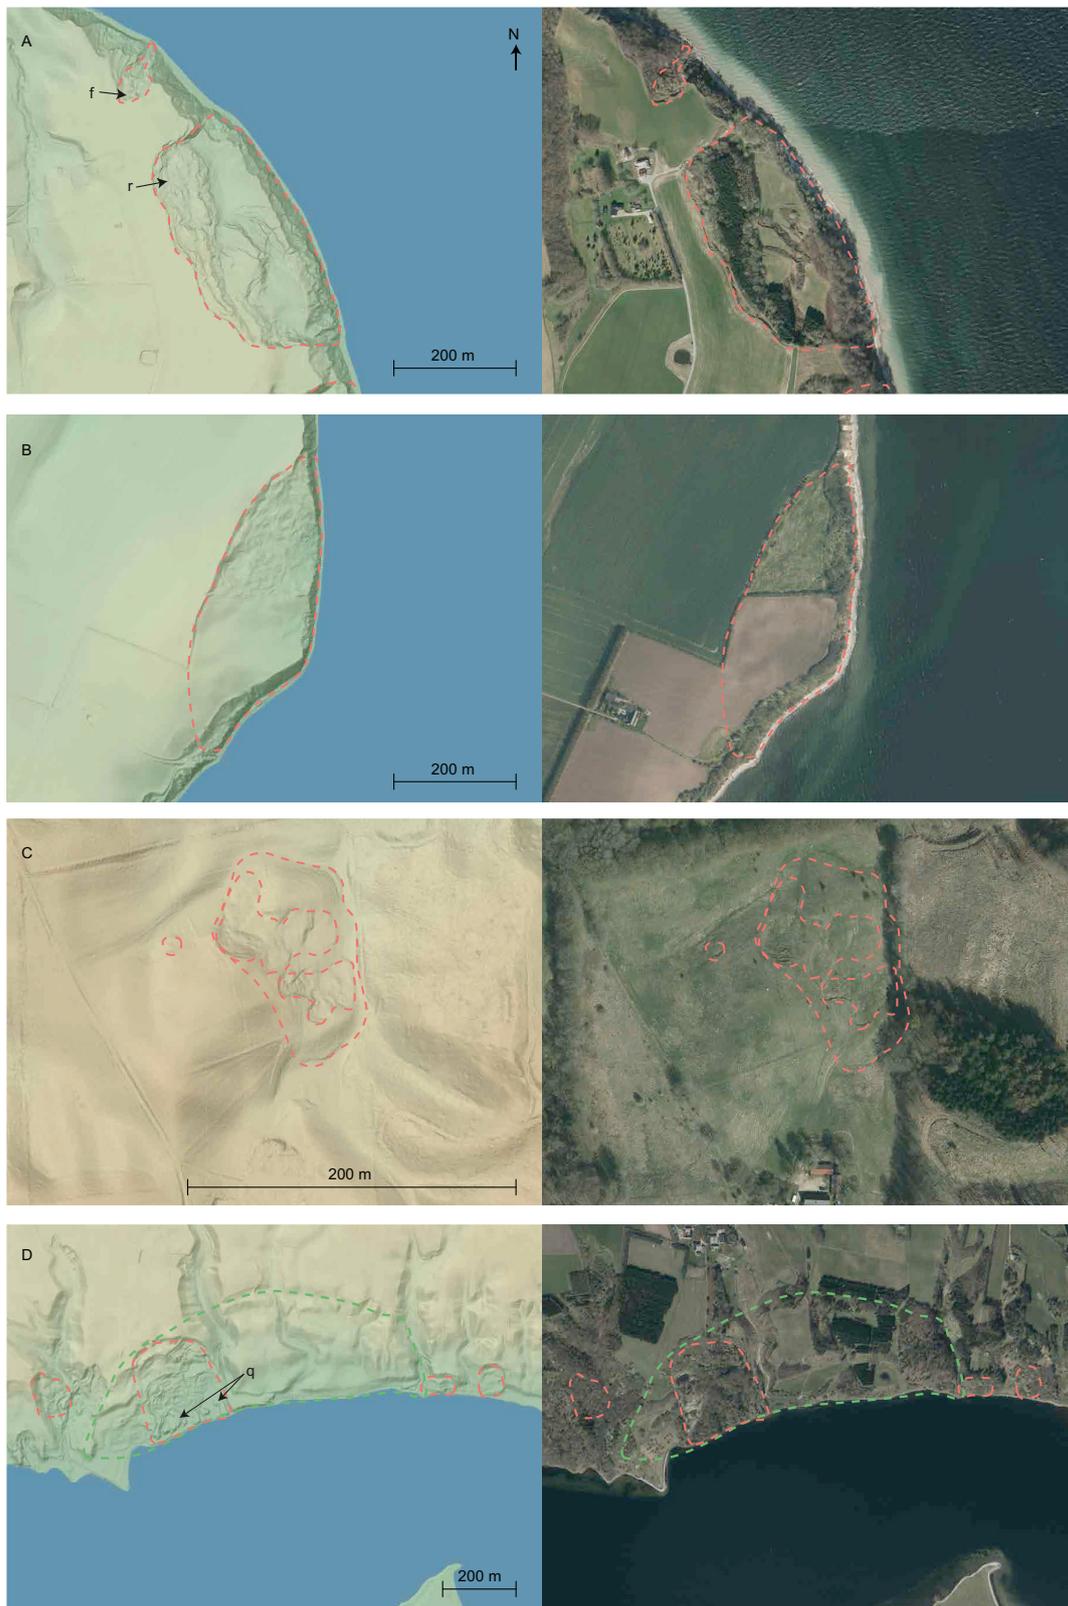
Fig. 2 Four examples of landslides from Denmark in the DEM hillshade (left) and an orthophoto (right). **A:** Large active rotational landslide (**r**) and flow (**f**), east of Røjle Klint, Fyn. **B:** Large rotational landslide, north of Mors, northern Jylland; the southern part of the landslide is partially concealed by farming activities. The northern uncultivated part of the landslide has clear internal structures, while the southern part is ploughed annually obscuring structures. This landslide would not have been mapped if not for the structures in the northern part. **C:** Inland landslide near Vejle, Jylland, superimposed by smaller flows. The large landslide is presumably a rotational or translational landslide or a combination. **D:** Example of a landslide (green) eroded by fluvial incision and a younger landslide (red) in Mariager Fjord, Jylland. Structures in the young landslide are somewhat obscured by quarrying (**q**), which could have been a triggering factor for the landslide.

The mapping workflow is similar to that reported by Svennevig (2019) for mapping landslides in Greenland and a simplified version to that of Slaughter *et al.* (2017). A landslide was mapped when either a scarp or a displaced unit or both were clearly visible in the multidirectional hillshade model (Fig. 2A). We thus only include landslides with moderate to high confidence, similar to Burns & Madin (2009) and Slaughter *et al.* (2017). Moreover, based on the high-quality and detail of the DEM, as well as the support of the observations with the time series of orthophotos (Table 2), we consider all the mapped landslides to be identified with high confidence. We characterised each landslide by its morphological features following the idealised depiction and

Anthropogenic overprint, such as from cultivation, buildings and infrastructure, is commonly observed on many landslides and can obscure their expression in the DEM. Since farmland covers 56% of Denmark's surface, the chance that landslide structures are obscured by cultivation and thus not mapped is rather high (Fig. 2B). This is especially the case for shallow slides and inland landslides (Fig. 2C). Quarries can be overprinted by slides, potentially having a triggering effect (Fig. 2D), but old unmapped quarries may also be mistaken for landslides.
